TECHNICAL MEMORANDUM

Project: Cities of Lathrop and Manteca
Urban Levee Design Criteria (ULDC) Evaluation

Subject: 7.10 – Erosion

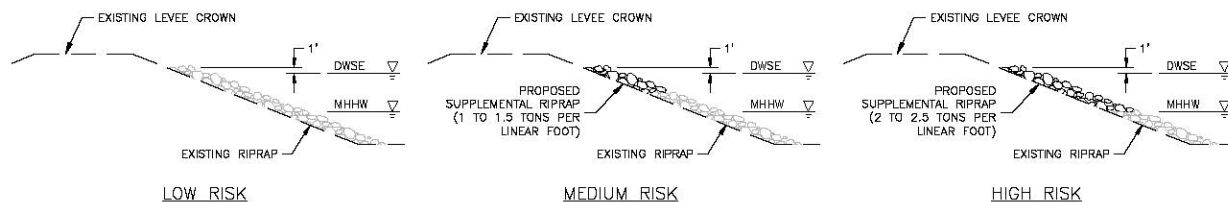
Lastly, a field survey was performed to ascertain the level of slope protection coverage. Since it was previously determined that a potential for erosion did exist, it was important to quantify any slope protection deficiencies. Quarry stone riprap rock is the primary form of slope protection utilized on RD17 levees. Originally the U.S. Army Corps of Engineers generally constructed rock slope protection only up to approximately Mean Higher High Water (MHHW) level. Over the years RD17 has worked to achieve a higher level of protection up to DWSE plus 1'. Levee reaches in which adequate rock slope protection exists up to the DWSE plus 1' or in which a substantial waterside berm exists were deemed a Low Hazard. Levee reaches in which 1 to 1.5 tons of additional rock slope protection are required per linear foot of levee were deemed a Medium Hazard. Levee reaches in which 2 to 2.5 tons of additional rock slope protection are required per linear foot of levee were deemed a High Hazard. Typical levee sections are shown below in Figure 1.

Figure 1 - Erosion Hazard Levels

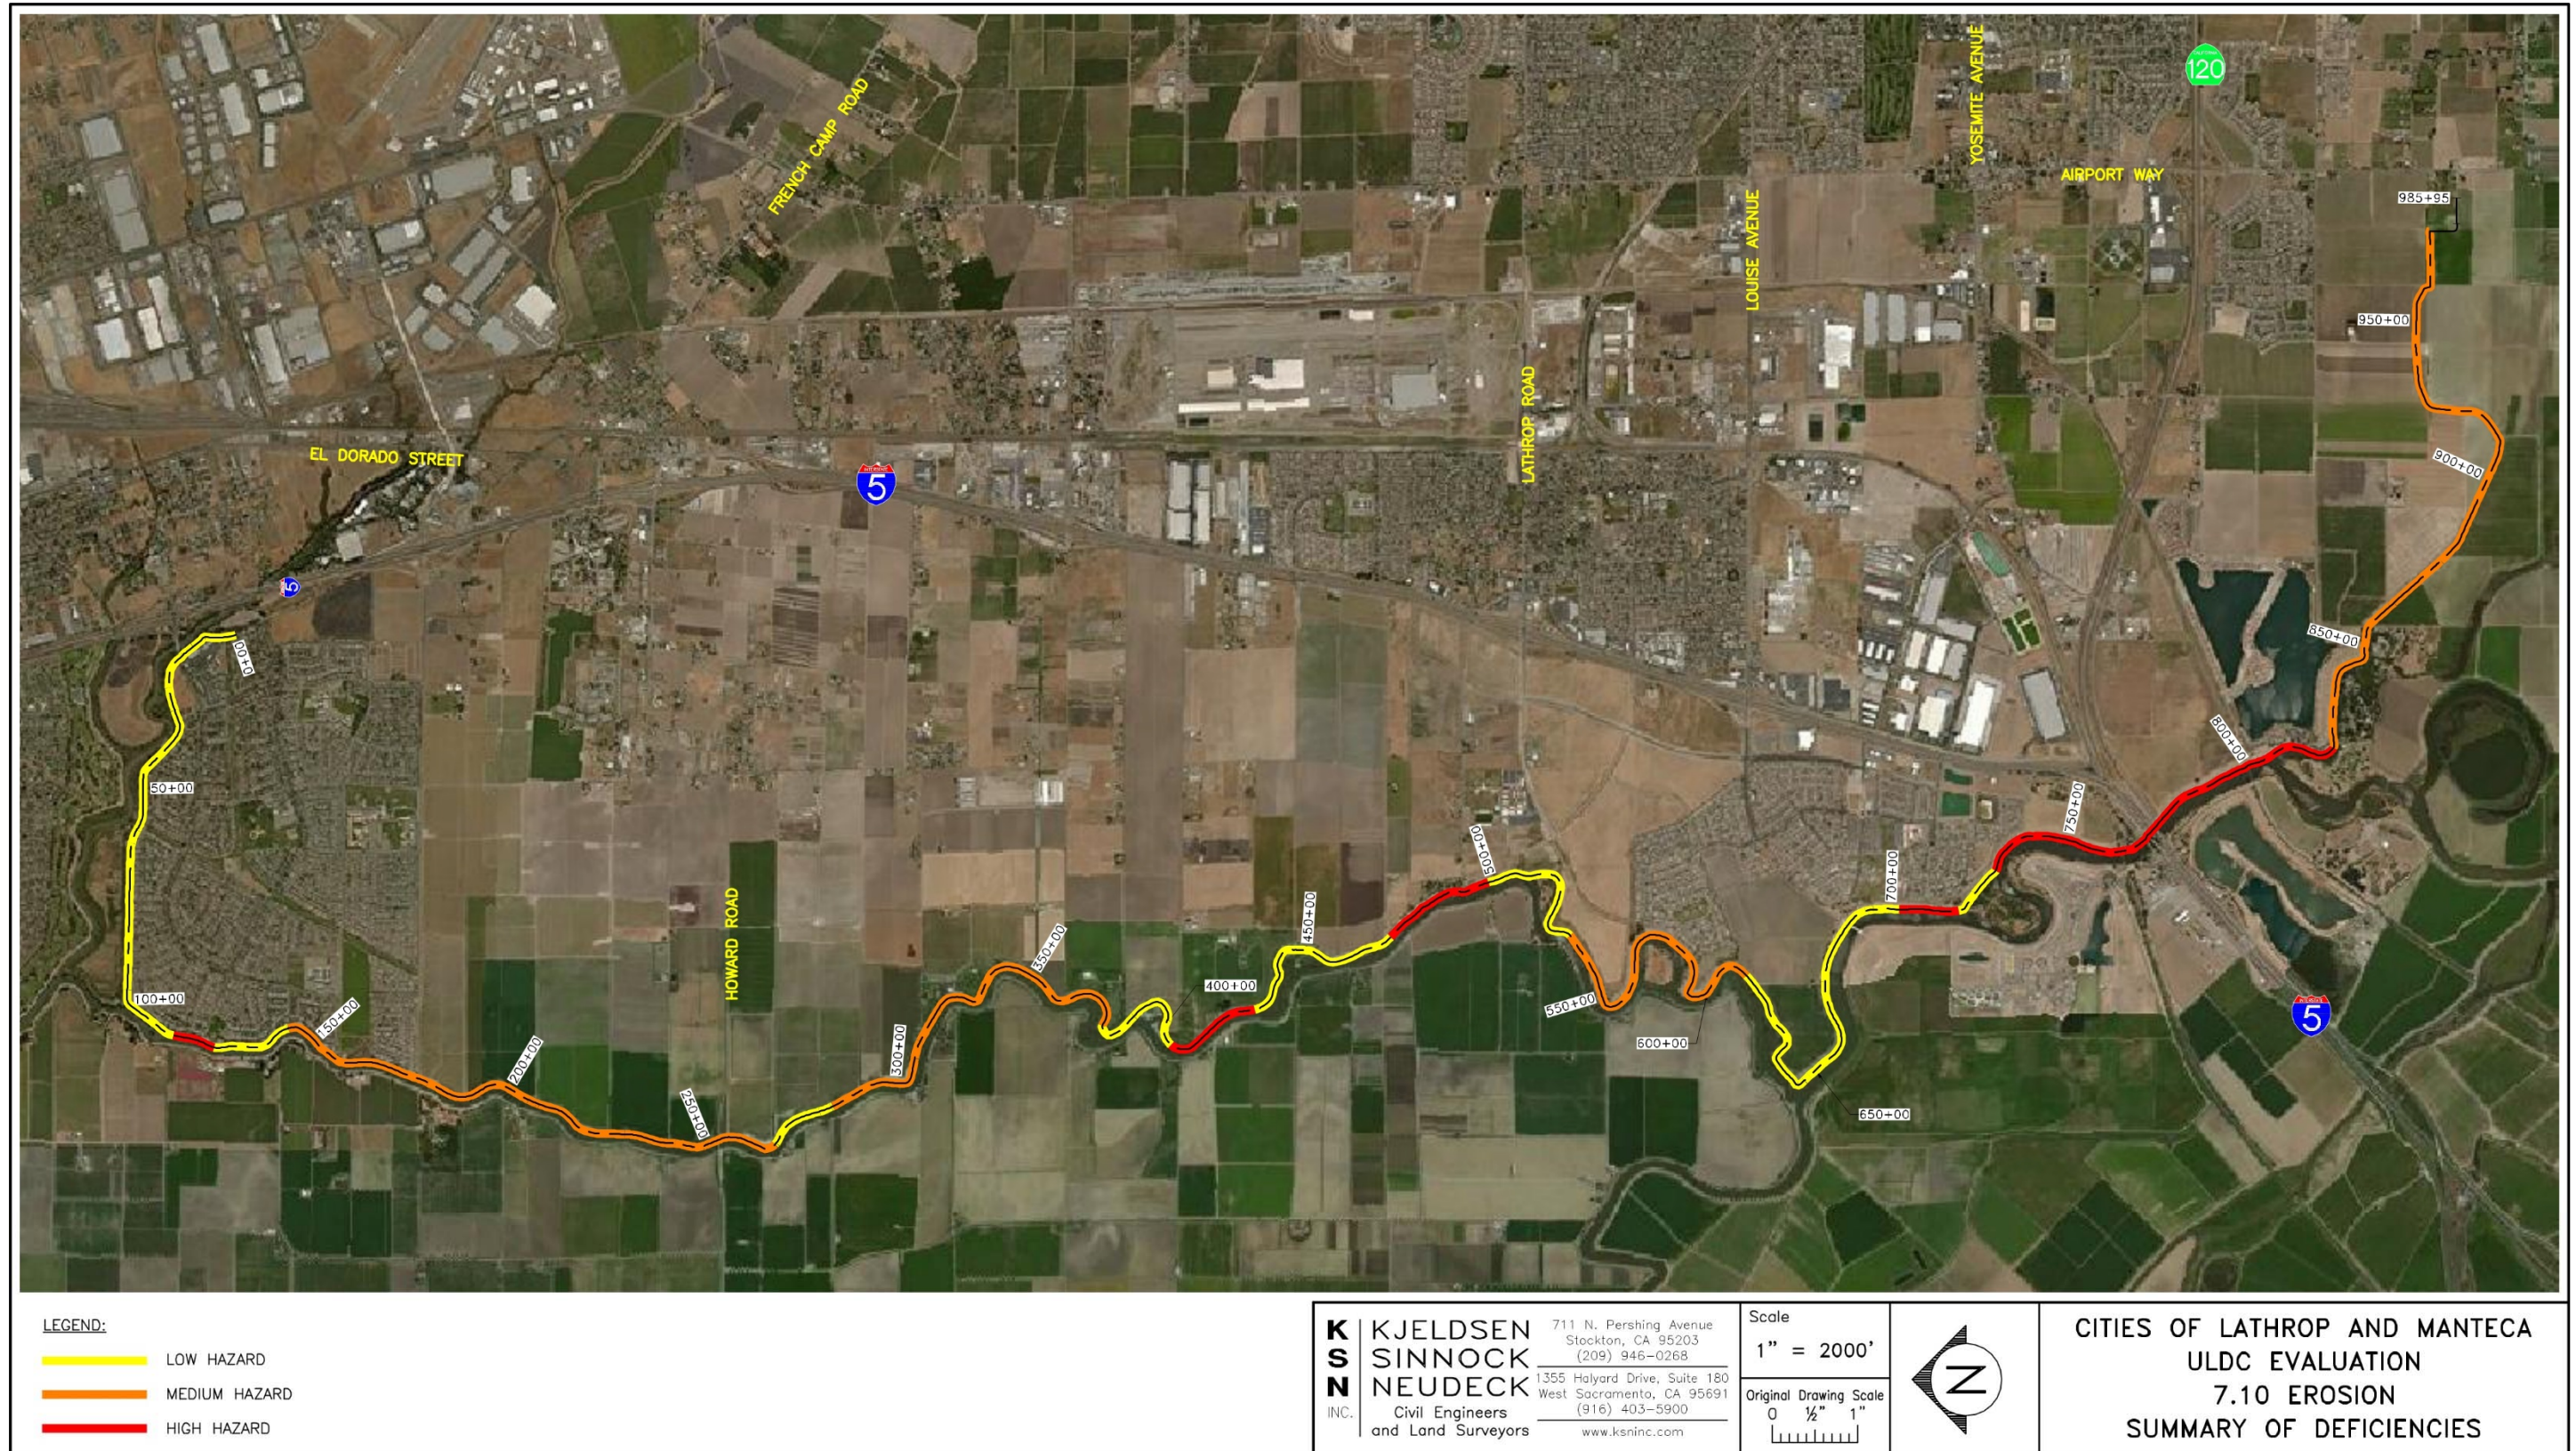
Figure 2 - Summary of Deficiencies

It is recommended that all levee reaches deemed a Medium or High Hazard be reconstructed in compliance with ULDC guidelines consisting of providing supplemental quarry stone riprap rock slope protection up to the DWSE plus 1'. Resolution to the identified deficiencies has been addressed as indicated in the proposed ULDC improvement plans and cost estimate. Figure 2 consists of an overall map that summarizes the deficiencies of the RD17 levee system with respect to erosion.
