## TECHNICAL MEMORANDUM

Project: Cities of Lathrop and Manteca  
Urban Levee Design Criteria (ULDC) Evaluation

Subject: 7.15 – Animal Burrows

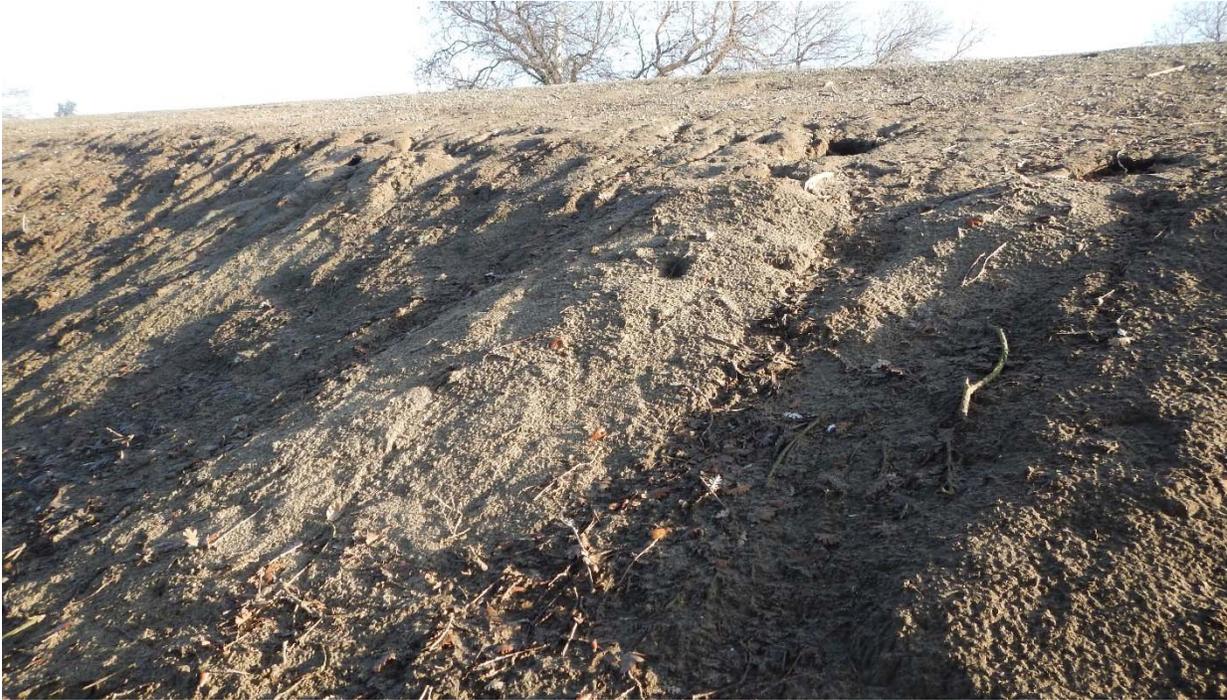
The analysis of animal burrows consisted of performing a field survey of the RD17 levees. Levee reaches were categorized based on the level of visible rodent activity. Levee reaches that contained little to no rodent activity were deemed a Low Hazard. Levee reaches that contained light to medium rodent activity were deemed a Medium Hazard. Levee reaches that contained heavy rodent activity were deemed a High Hazard. Representative photographs of Medium Hazard and High Hazard levee reaches are shown below in Figures 1 and 2.

**Figure 1 - Representative Photo of Medium Hazard Area**

As stated earlier, RD17 already implements a comprehensive animal control program. It is recommended that existing, ongoing operations and maintenance efforts for all levee reaches deemed a Medium or High Hazard be augmented to emphasize and better address animal control at these particular reaches. Figure 3 consists of an overall map that summarizes the deficiencies of the RD17 levee system with respect to animal burrows.

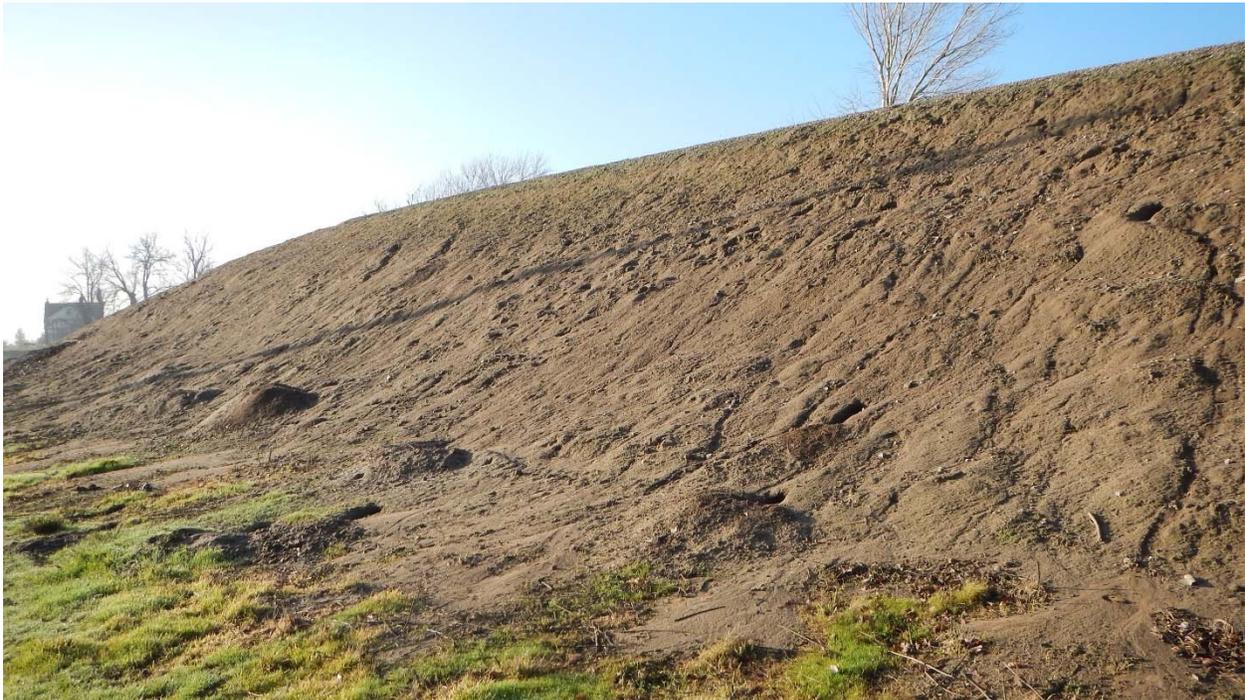
**Figure 2 - Representative Photo of High Hazard Area**

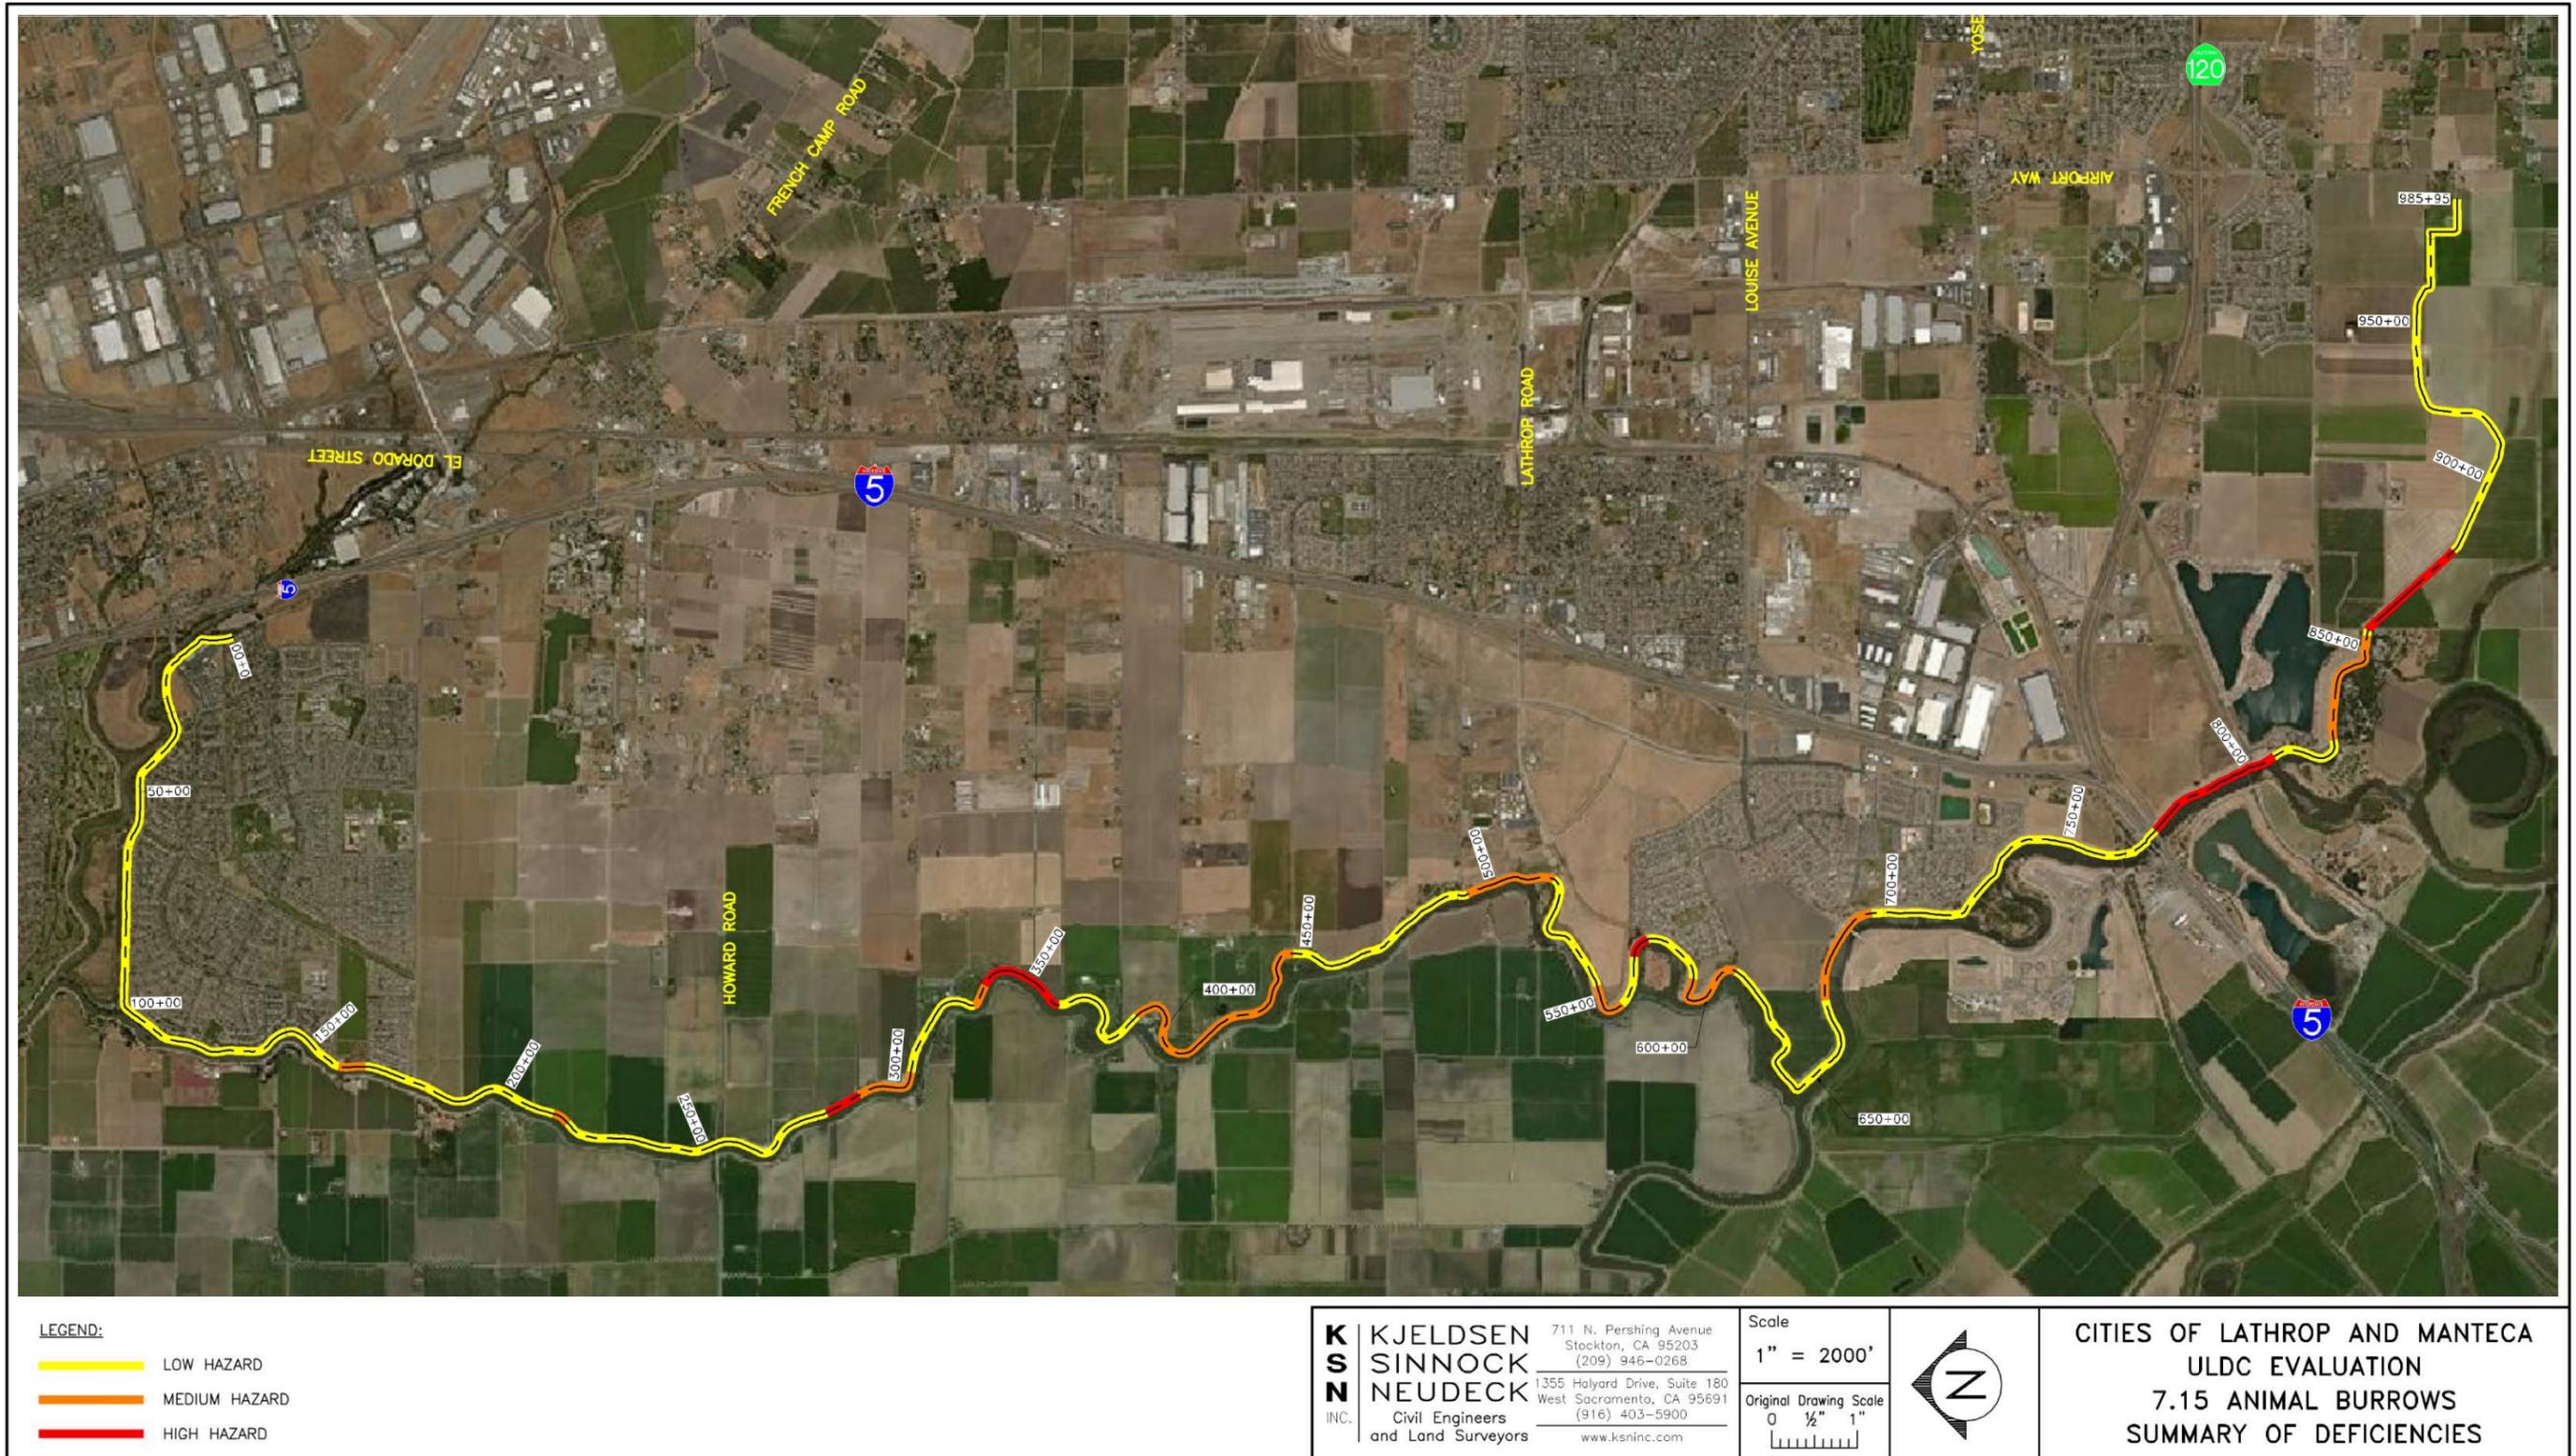
Figure 1 - Summary of Deficiencies
