## TECHNICAL MEMORANDUM

January 18, 2016

Project: Cities of Lathrop and Manteca  
Urban Levee Design Criteria (ULDC) Evaluation

Subject: 7.16 – Levee Vegetation

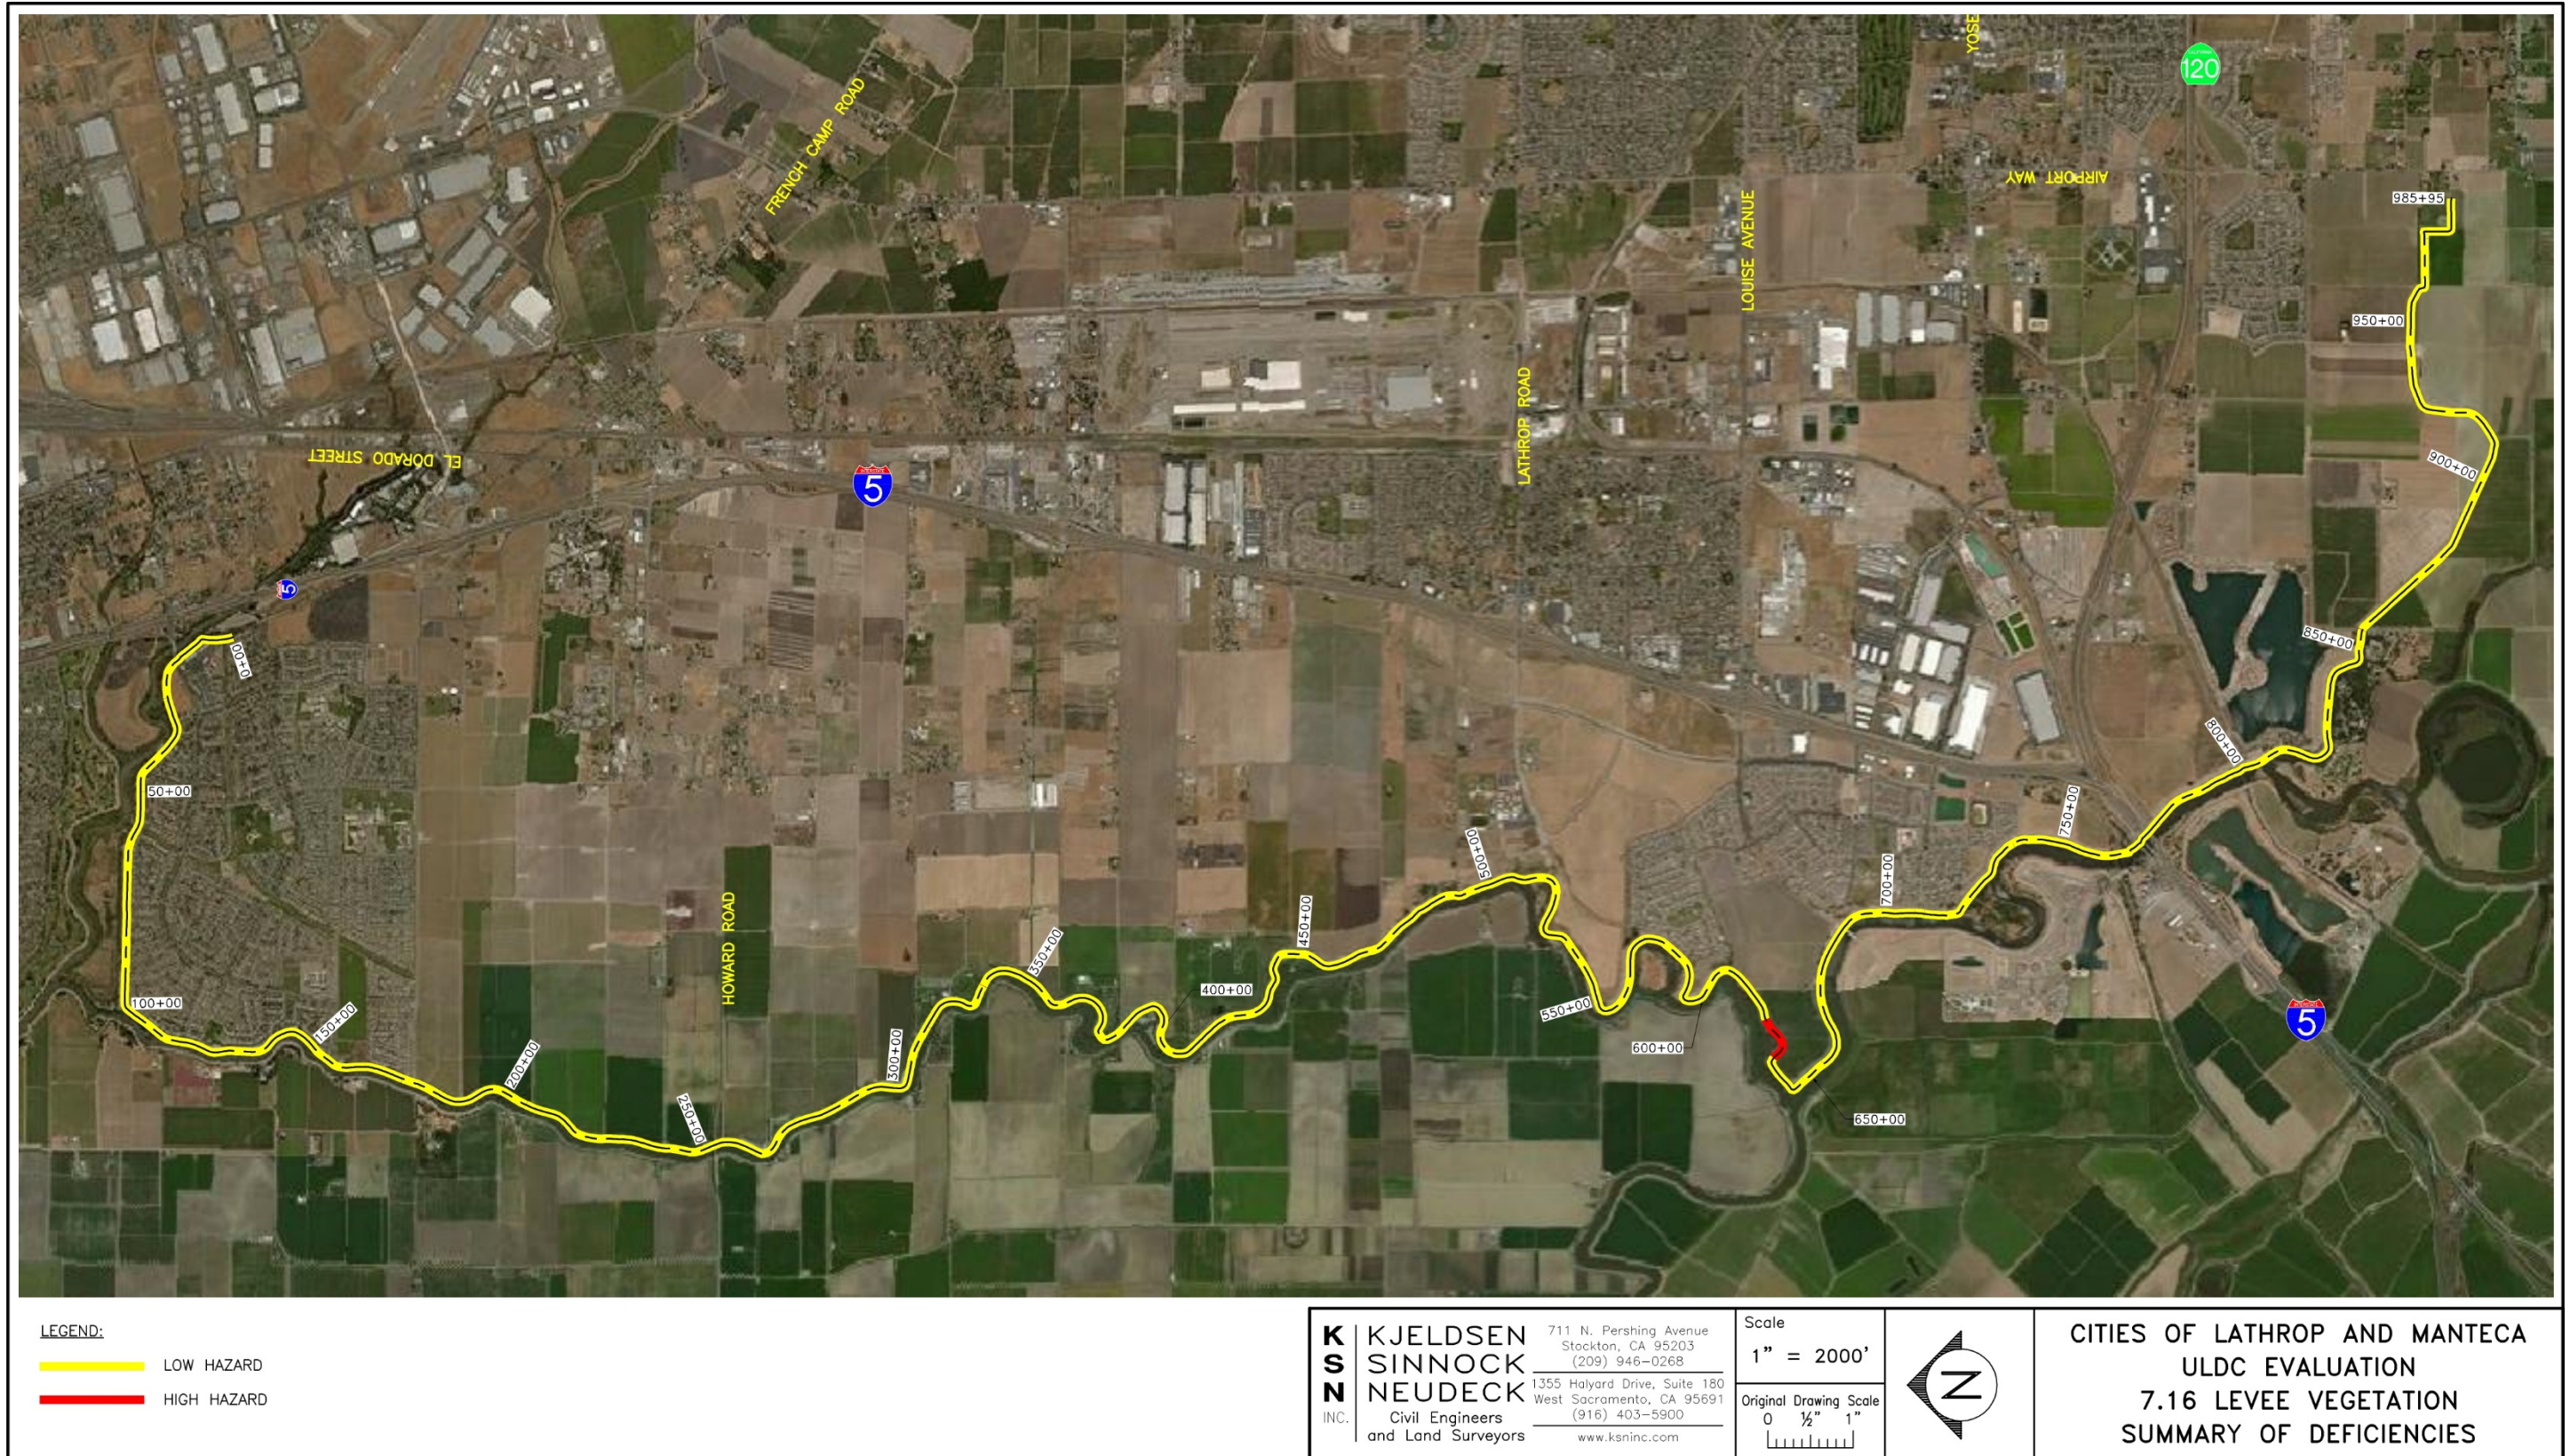
Figure 2 - Summary of Deficiencies

The levee sections that were identified as a High Hazard are indicated below in Table 2. These sections are deemed deficient.

| Station from | Station to | Length (feet) | Deficient Items |
|---|---|---|---|
| 327+72 | 327+82 | 10 | tree limbs |
| 337+34 | 337+44 | 10 | tree limbs |
| 623+89 | 635+03 | 1,114 | groundcover + tree limbs |

As stated earlier, RD17 currently implements a comprehensive vegetation control program. It is recommended that existing, ongoing operations and maintenance efforts for all levee reaches deemed a High Hazard be augmented to emphasize and better address vegetation control at these particular reaches. Figure 2 consists of an overall map that summarizes the deficiencies of the RD17 levee system with respect to levee vegetation.
