City of Lathrop and City of Manteca ULDC Evaluation Assessment of Existing Penetrations

Prepared for: City of Lathrop & City of Manteca

March 1, 2016

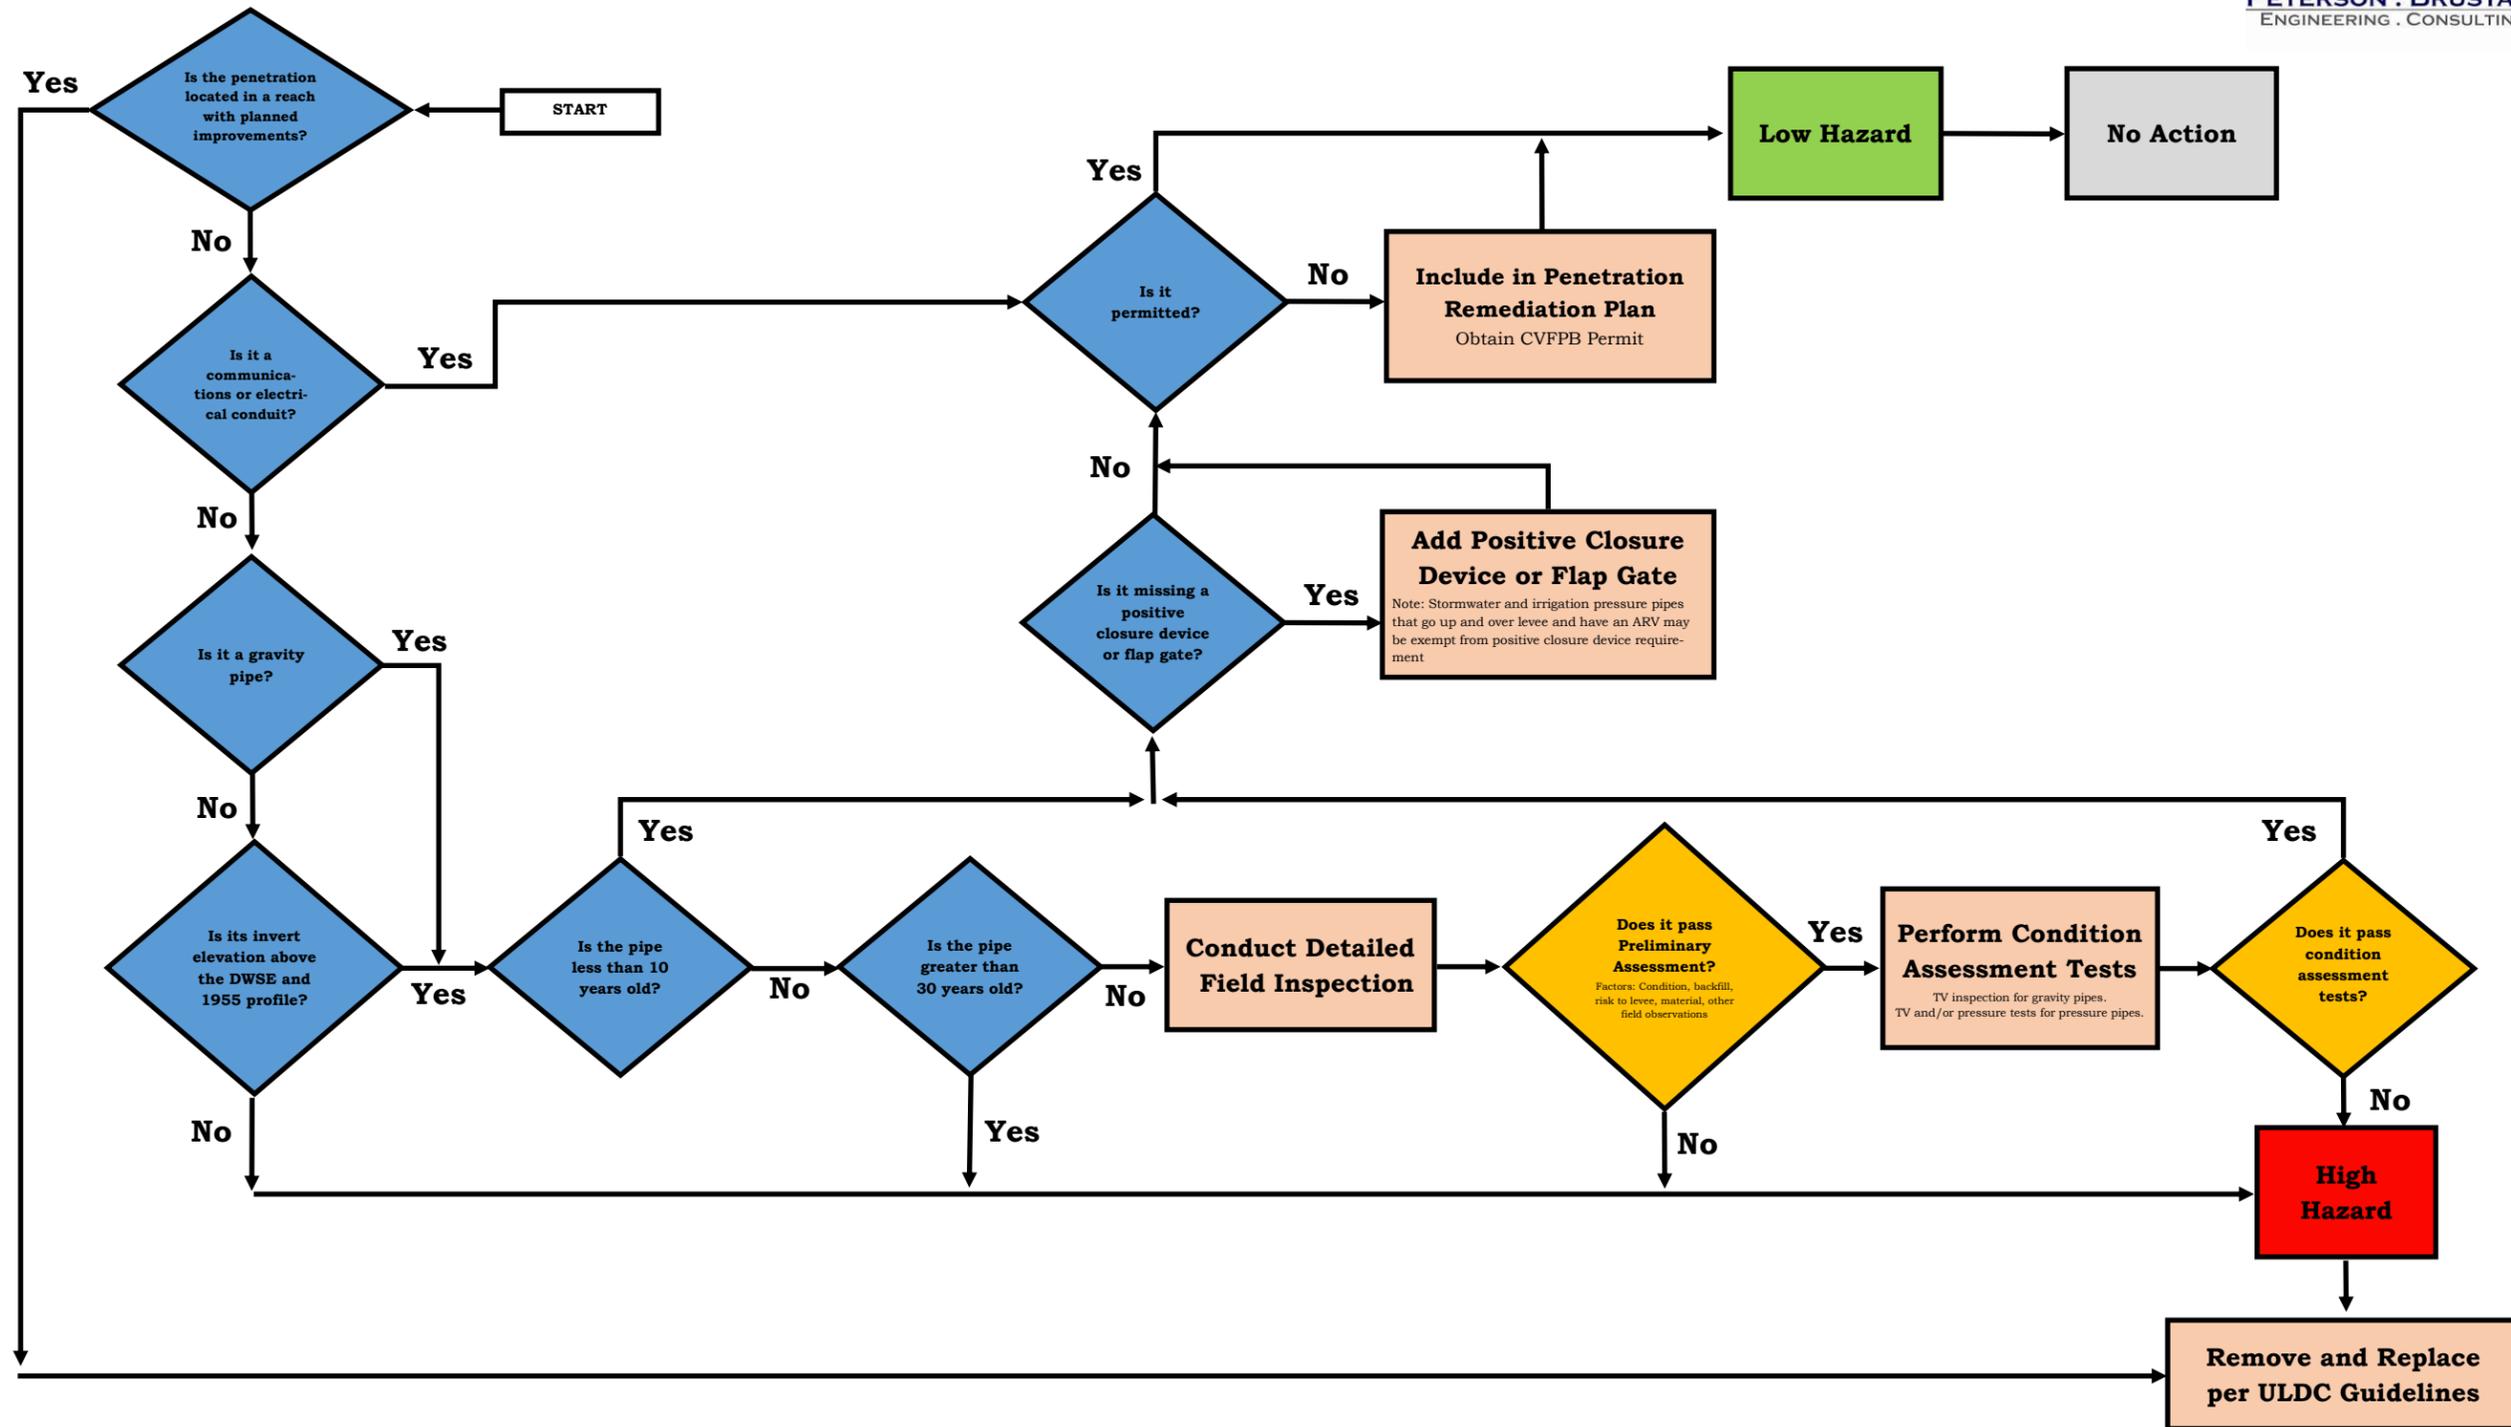
Figure 1: ULDC Penetration Assessment Decision Tree

The hazard of each levee penetration outside of “work reaches” was assessed using a multi-step process detailed in a decision tree shown in Figure 1. Penetration characteristics were identified, including type of penetration, its location in the levee, and age. Conditions were not assessed for penetrations located in reaches where levee improvement projects are scheduled with the assumption that these penetrations will be removed and replaced as a necessary part of the overall levee improvement project.
